# Lifeline Foods Mill Building Renovation

## **Lifeline Foods Dry Mill**

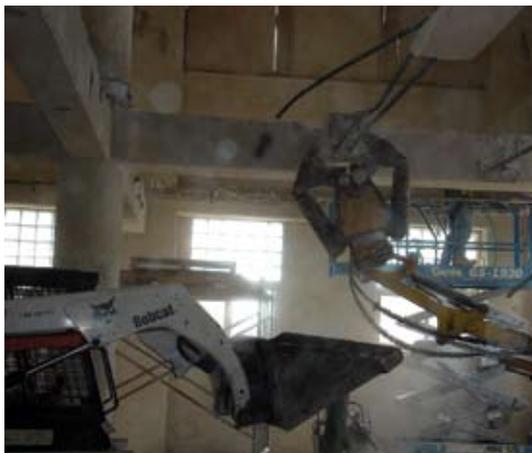
*Demolition of interior beams*

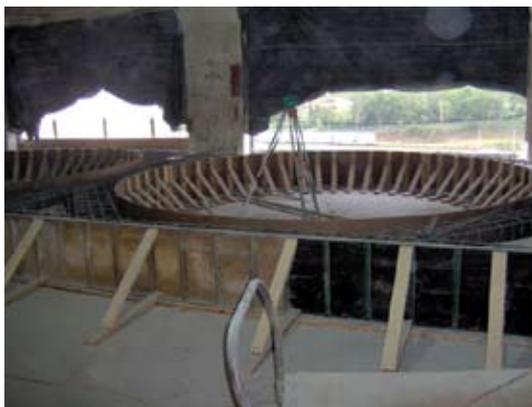
*Large diameter tank supports*

Areas that were to receive very heavy tanks were dealt with by building cast-in-place beams over the existing slab (up-turned beams) that resulted in a clean surface to mount the tanks and prevent vermin hiding locations. The ends of the slabs were tied into the columns.

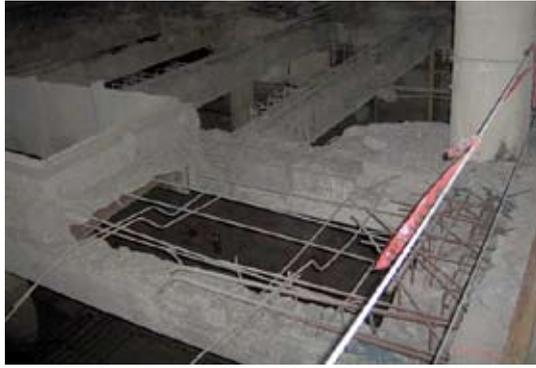
*Floor perforations being built*

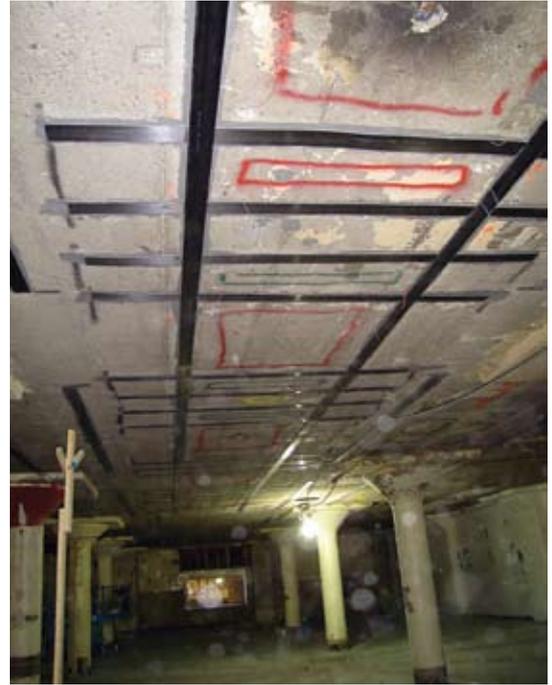
*CFRP installed in ceiling*

15,000 ft (4472 m) of new CFRP was eventually installed to repair the slabs. Over 600 floor perforations from 8 in. to 17.5 ft (20 cm to 5.3 m) in diameter were added. Approximately 80,000 ft<sup>2</sup> (7432 m<sup>2</sup>) of new bonded concrete topping was added. Over 8000 ft<sup>2</sup> (745 m<sup>2</sup>) of reinforced concrete full-depth floor repair was constructed. Approximately 145,000 ft<sup>2</sup> (13,471 m<sup>2</sup>) of new epoxy wall and ceiling coatings were installed. Three 17.5 ft (5.3 m) diameter reinforced concrete upturned

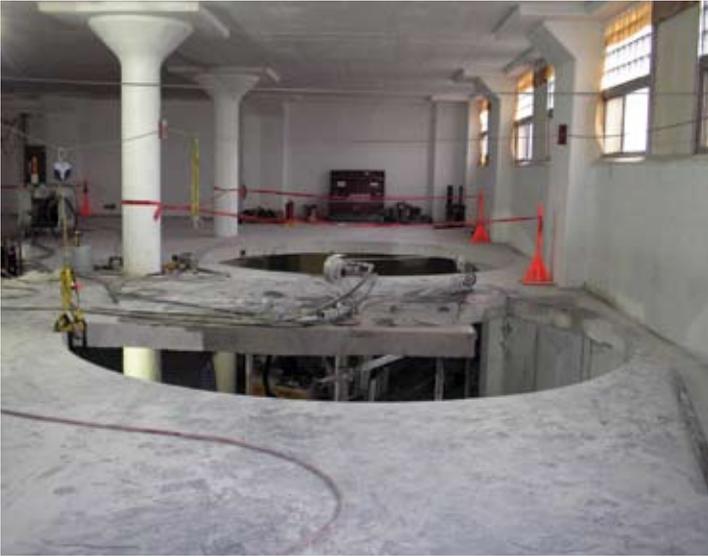
*New floor with perforations ready for equipment*

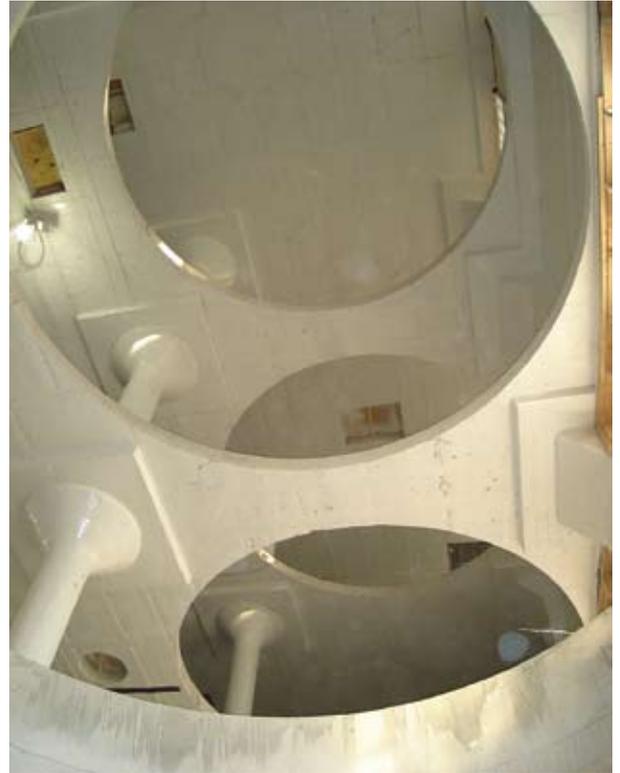
*Looking up through bin holes in new floor slabs*
