Cutting a Building Down to Size

Memphis VA Reduces Floor Levels to Meet Earthquake Specifications

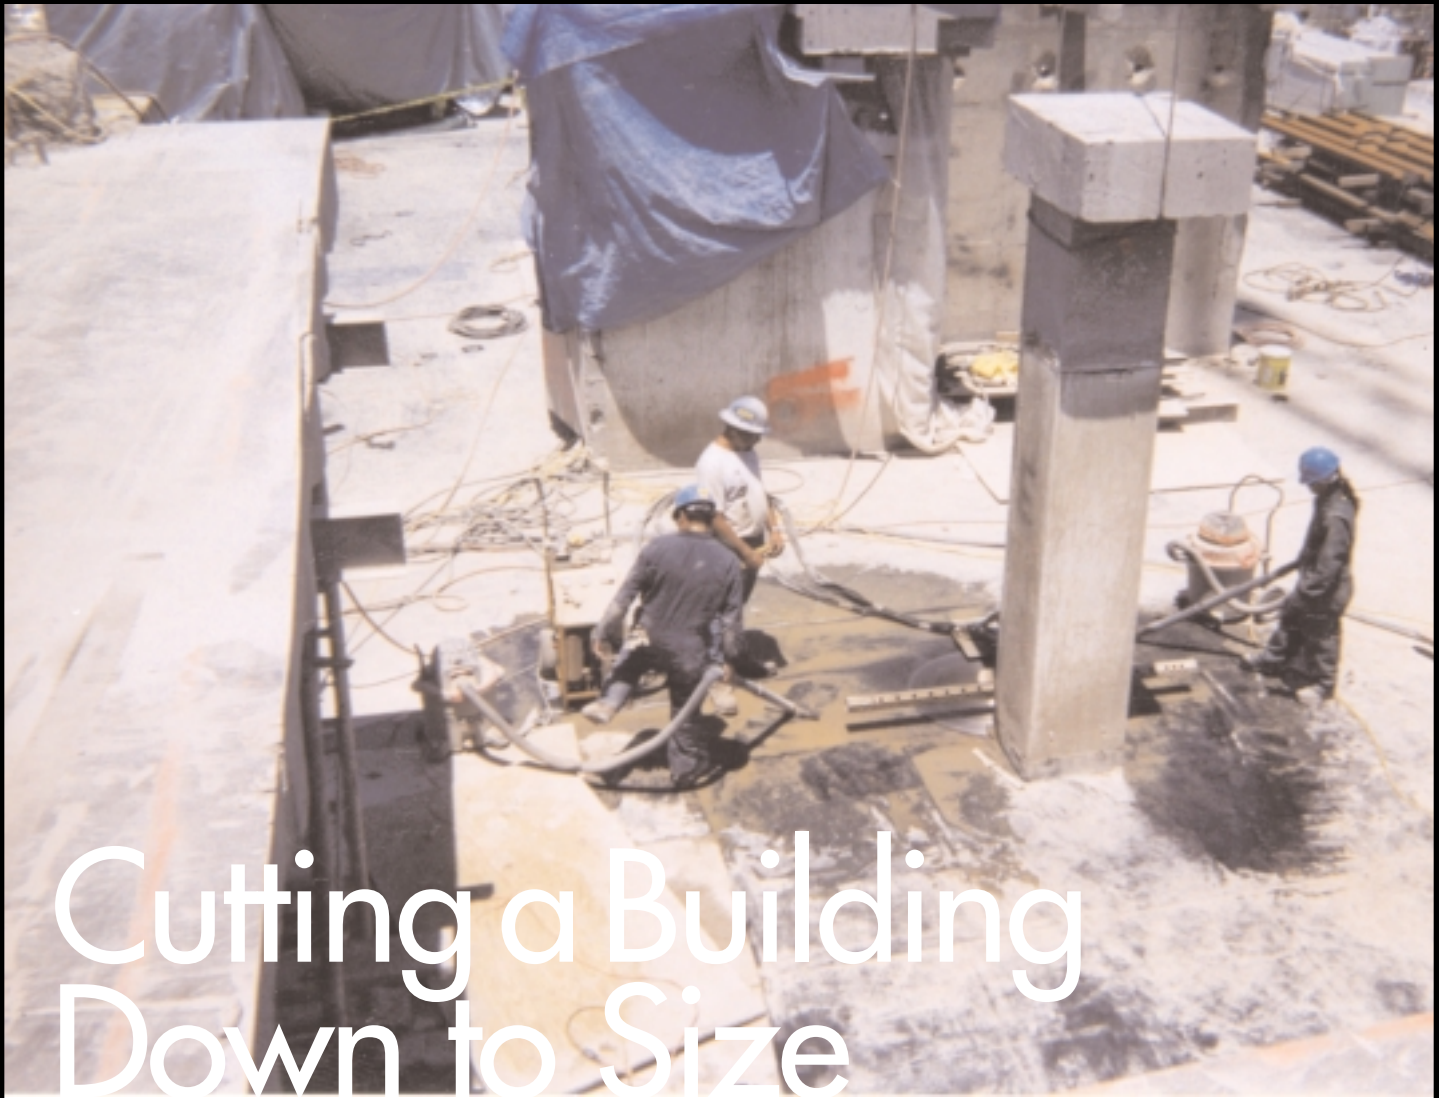
Above: The concrete support columns were cut flush with the floor with a slab saw.

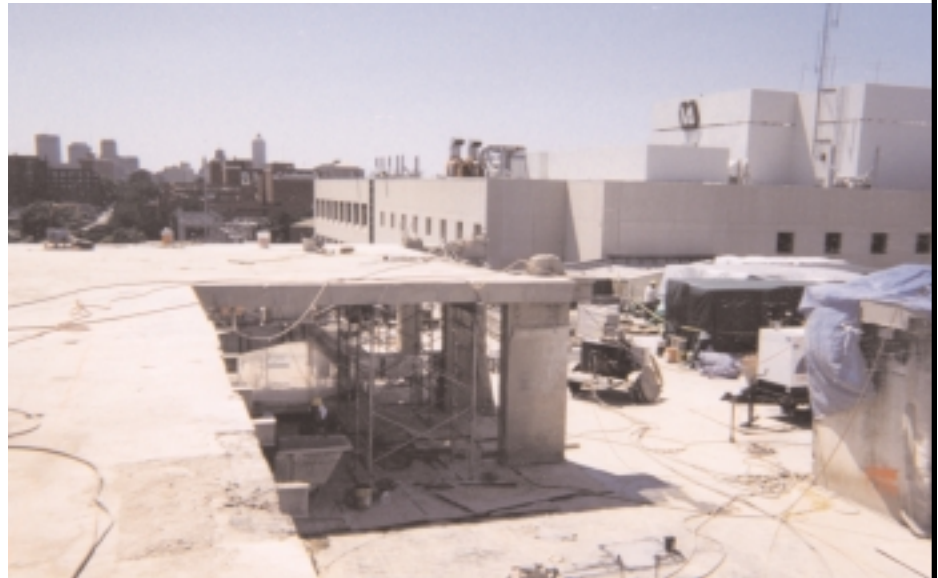
Above Top: The first step was to remove the cantilevered floor to be able to gain access to the concrete panels underneath.

Concrete cutting was required on the 6th floor because the 5th floor remained fully occupied by doctors, patients and hospital staff throughout the job. The walls on the 6th floor of the building were concrete panels. The first step was removing the cantilevered floor to be able to gain access to the concrete panels underneath so they could be safely raised out. Sections of the floor were cut out leaving the outer column to support the cantilevered beam. The 7-foot by 14-foot sections of floor were removed. Next the wall panels were cut and removed with a slab saw. After the panels were taken out, the beams were wire sawed from each side simultaneously and lifted away with ARC's tower cranes to trucks. When the beam was cut away from the column, the column was then flush cut with the lower floor. The connecting pieces were then sawed away with wall saws because there was no access for a slab saw.

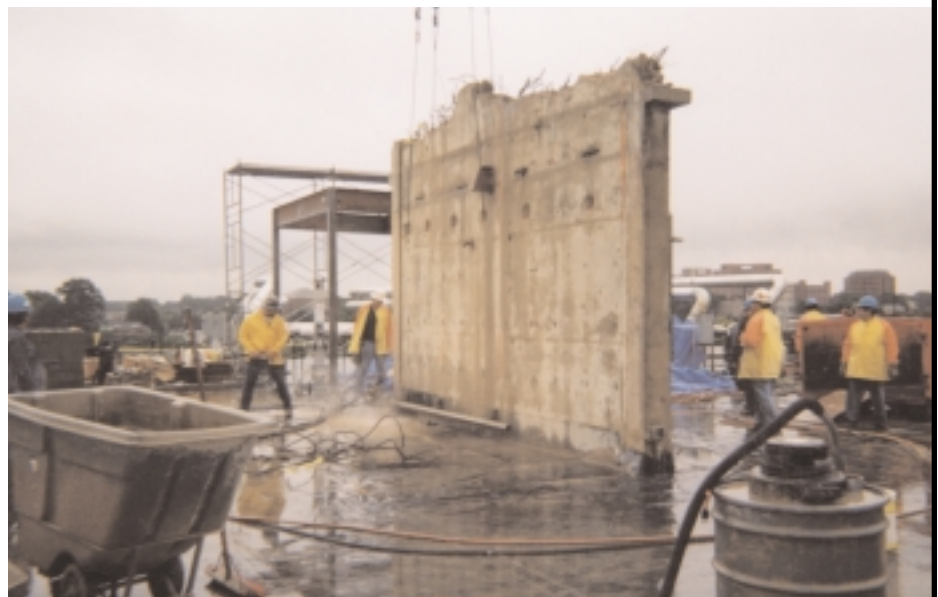
Above Bottom: Operators worked in the rain to remove one of the last remaining wall panels on the 6th floor.
